Successful Conservative Management of Right Ventricular Perforation Caused by Temporary Pacemaker Placement during Complex Percutaneous Coronary Intervention: A Case Report

Fadhil P. Apriansyah^{1,2}, Muhammad Munawar^{1}, Dian L. Munawar¹, Beny Hartono¹, Muhammad Fadil¹, Darwin Indra¹*

¹Binawaluya Cardiac Center, Jakarta, Indonesia

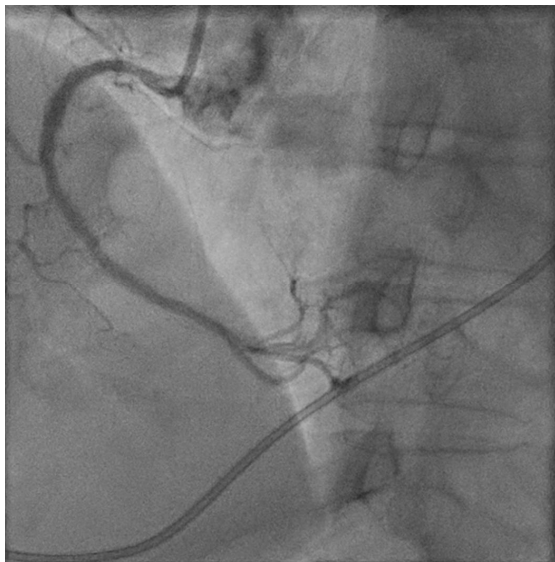
Figure 5. Repeat coronary angiography revealed no evidence of occlusion or perforation. A pigtail catheter was inserted into the pericardium via subxiphoid access.

A repeat coronary angiography was conducted, revealing no occlusion or perforation in the RCA (**Figure 5**). To exclude the possibility of distal coronary perforation, a microcatheter was used for tip injections into all branches of the RCA, confirming the absence of perforation. Thus, perforation of the RV wall due to the TPM lead was determined to be the most probable

Identifying the aetiology of cardiac tamponade in this scenario presented diagnostic challenges. Initially, coronary perforation was a primary concern due to the recent complex PCI involving rotational atherectomy. However, subsequent coronary angiography and microcatheter injections revealed no evidence of coronary artery perforation, making perforation of the RV wall by the TPM lead the most probable diagnosis. In some cases, spontaneous closure of the defect or perforation may occur immediately after the TPM lead is withdrawn due to myocardial contraction. However, several factors can prevent spontaneous closure, including the use of antiplatelet and anticoagulant agents, as observed in our case. Although advanced imaging modalities such as computed tomography (CT) or right ventriculography could

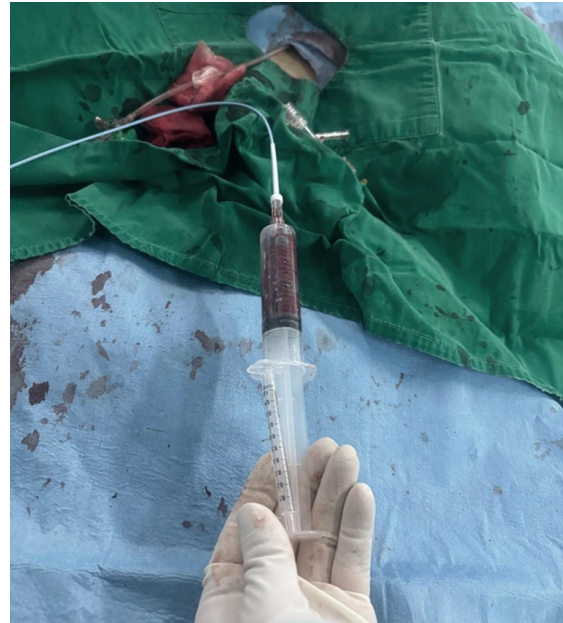
Figure 6. A pigtail catheter connected to a 20cc syringe, which was placed in a negative pressure state using a smaller syringe to create suction. This setup facilitates the continuous drainage of pericardial fluid and promotes the adhesion of the pericardium to the epicardium.

Continuous pericardial tapping through a pigtail catheter enabled sustained drainage of pericardial fluid. The application of sustained negative pressure facilitated the adherence of the pericardium to the epicardium, promoting the sealing of the RV wall perforation and preventing fluid reaccumulation. Maintaining the negative pressure system stopped the bleeding without the need for open-heart surgical intervention. This case exemplifies how non-invasive techniques can yield favorable outcomes when appropriately executed promptly, highlighting the importance of individualized patient management in the treatment of cardiac complications.
